The Destruction of Archaeological Resources in the Palestinian Territories, Area C Kafr Shiyān as a Case Study

Salah Hussein A. Al-Houdalieh and Saleh Ali Tawafsha

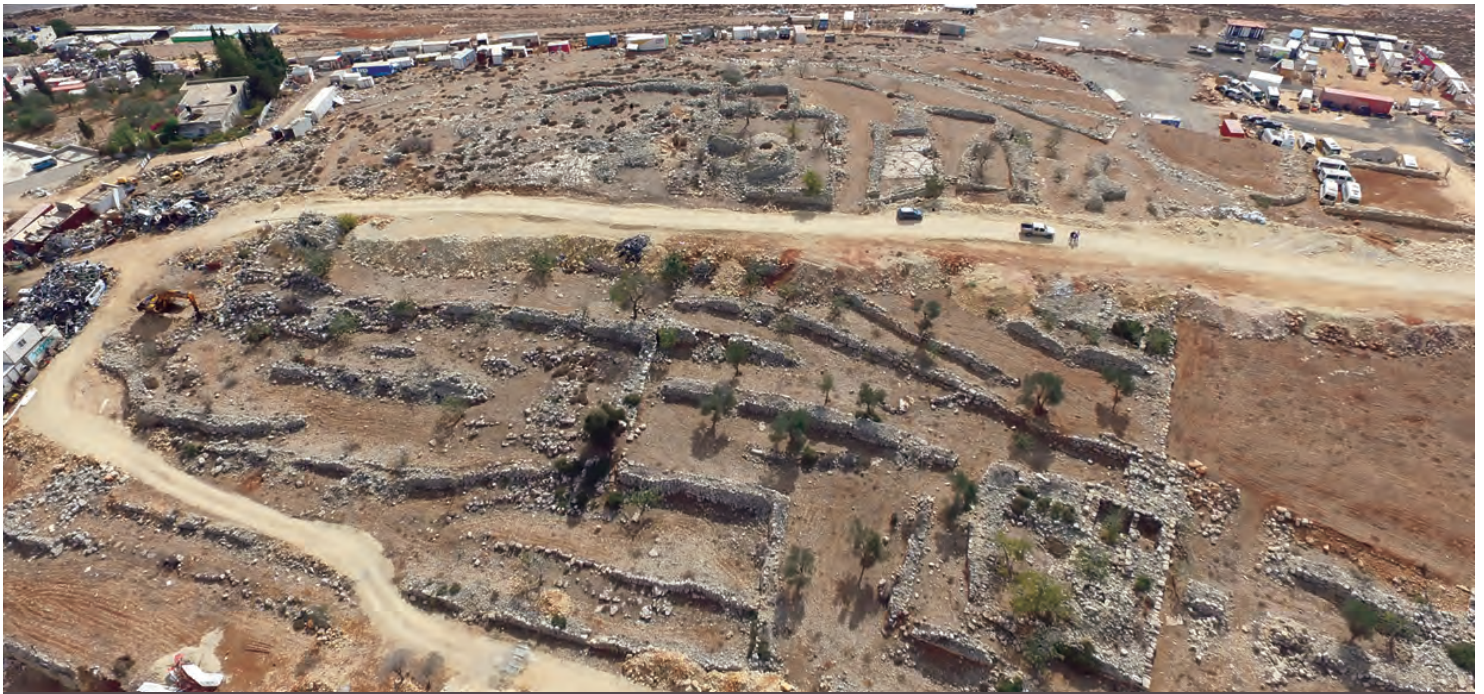
Aerial photograph of Khirbet Kafr Shiyān in 2016, looking south. Photo by Maher Barghouthi.

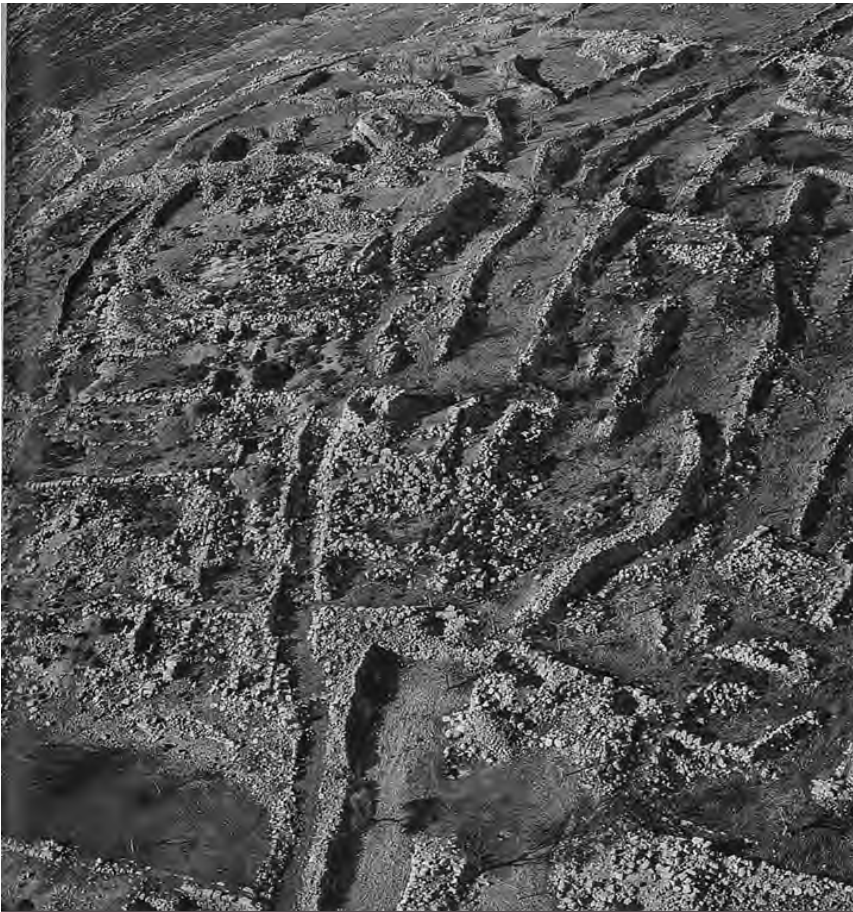
Figure 1. Khirbet Kafr Shiyān in 1986, looking west. From Finkelstein and Lederman 1997: 343.

We documented the remains of a large number of ancient walls located all over the khirbet (figs. 1, 3, and 5). They are built of large, well-cut stones laid in regular courses, two stones thick and 1 m in total thickness on average. The walls survive in height from a few centimeters up to 4 m above the present ground level (fig. 5). The interstices between the stones were filled with small stones and earthen mud. The walls were coated with at least one

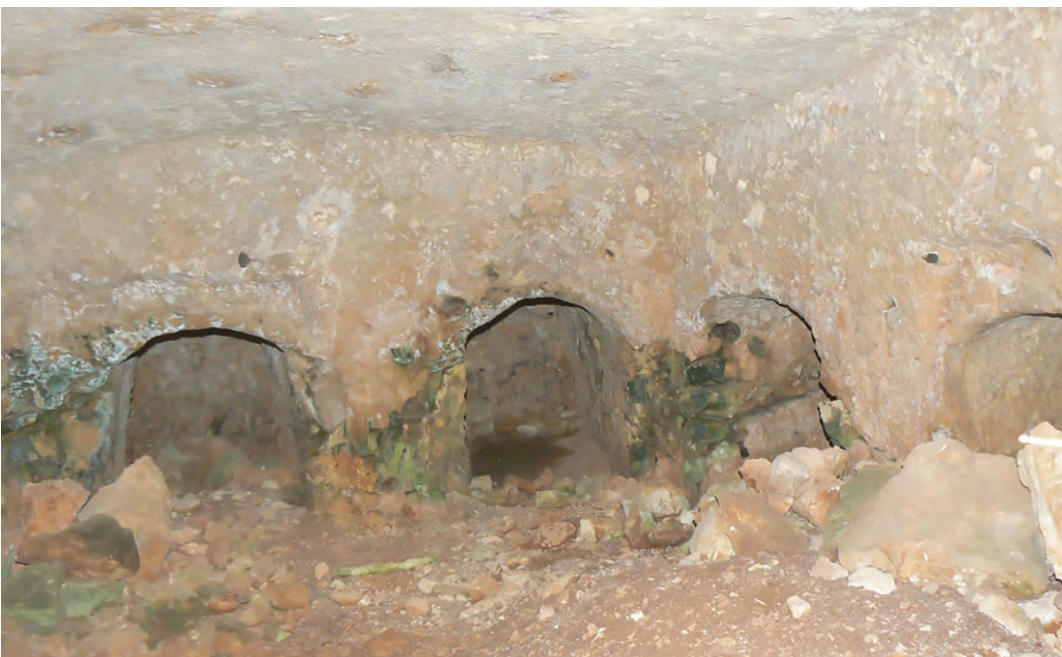
Figure 2. Roman-era looted tomb, 2011. Photo by S. Al-Houdalieh.

In 2011, Al-Houdalieh visited the site in the course of his research study entitled “Tomb Raiding in Western Ramallah Province” and documented more than thirty-five looted, subterranean, rock-cut Roman-period tombs of the loculi type on the western side of the site. They were located approximately 10 to 12 m apart from each other and had been heavily vandalized. Each tomb chamber featured three to five loculi, and some included square depressions in their floor surface (fig. 2).

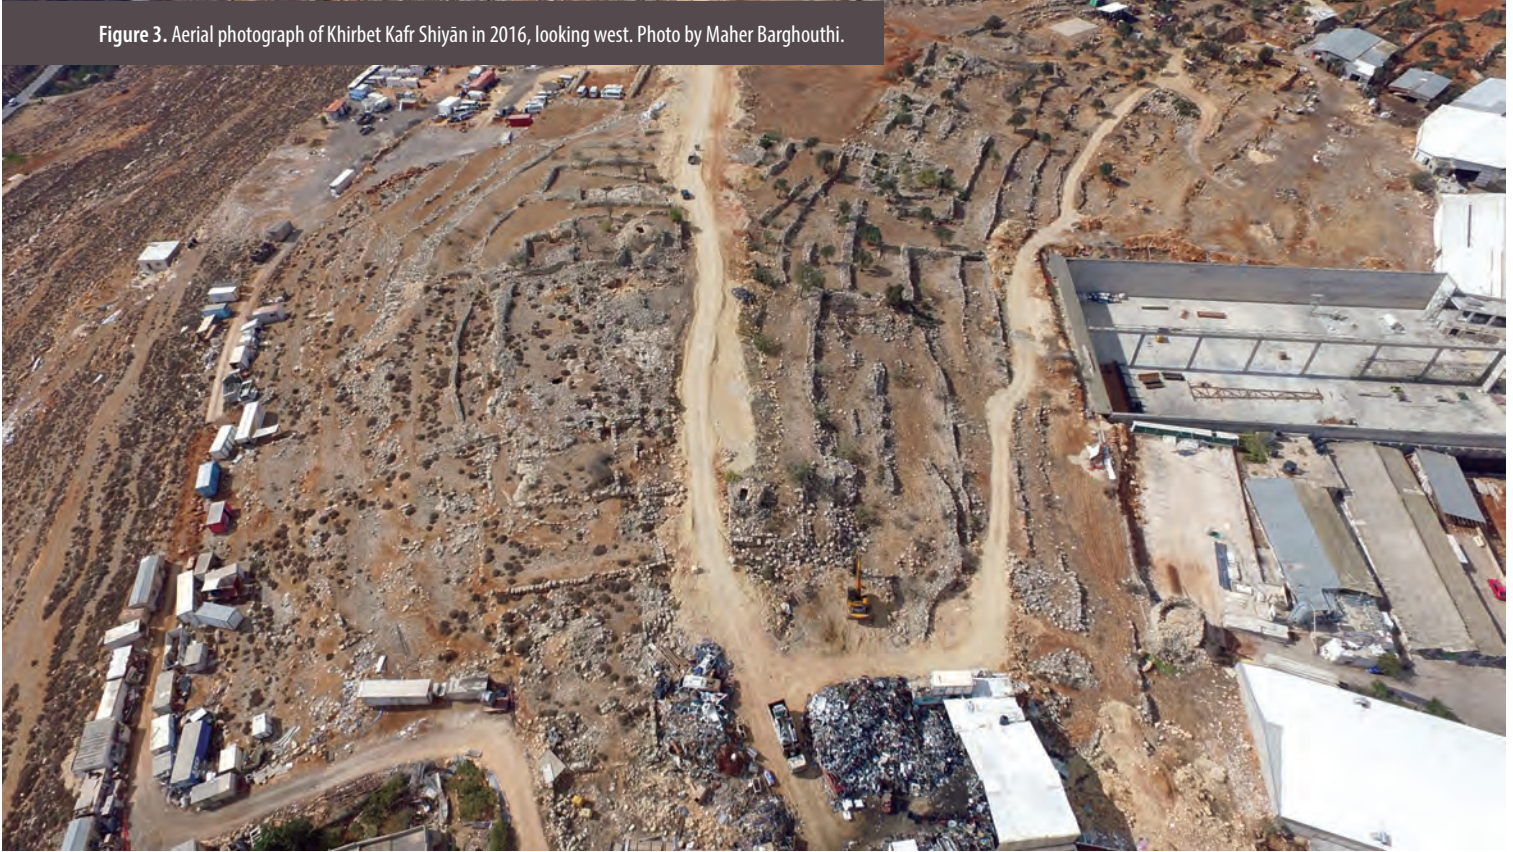
Figure 3. Aerial photograph of Khirbet Kafr Shiyān in 2016, looking west. Photo by Maher Barghouthi.

We conducted a survey of the khirbet in October and November 2016, which documented within the study area the following: six watchtowers, a large number of agricultural terrace walls, remains of a large number of ancient rooms, five cisterns, two man-made caves, thirty-five looted tombs, thirty-one holes caused by antiquities looters, four modern roads, eighty caravan trailers, and twelve new residential, industrial, or commercial buildings (fig. 3).

number of terrace walls of various dimensions were documented at the khirbet, some more than 60 m long \times 2 m high \times 1.8 m thick, on average, while the majority are of lesser dimensions (fig. 3). These terrace retaining walls were built from different sized stones, both worked and unworked, laid in irregular courses and mostly on top of much older wall remains. Some of these terrace walls incorporate column drums of various diameters and lengths (fig. 9). It is believed that the local farmers obtained the material required for these walls by collecting stones found scattered in their own fields. Most of these terraces are now either damaged or almost completely destroyed due to several factors: the abandonment of necessary maintenance over the last few decades, the grazing of animals on the site, erosion suffered during the winter rainy seasons, and the various activities of urban development.

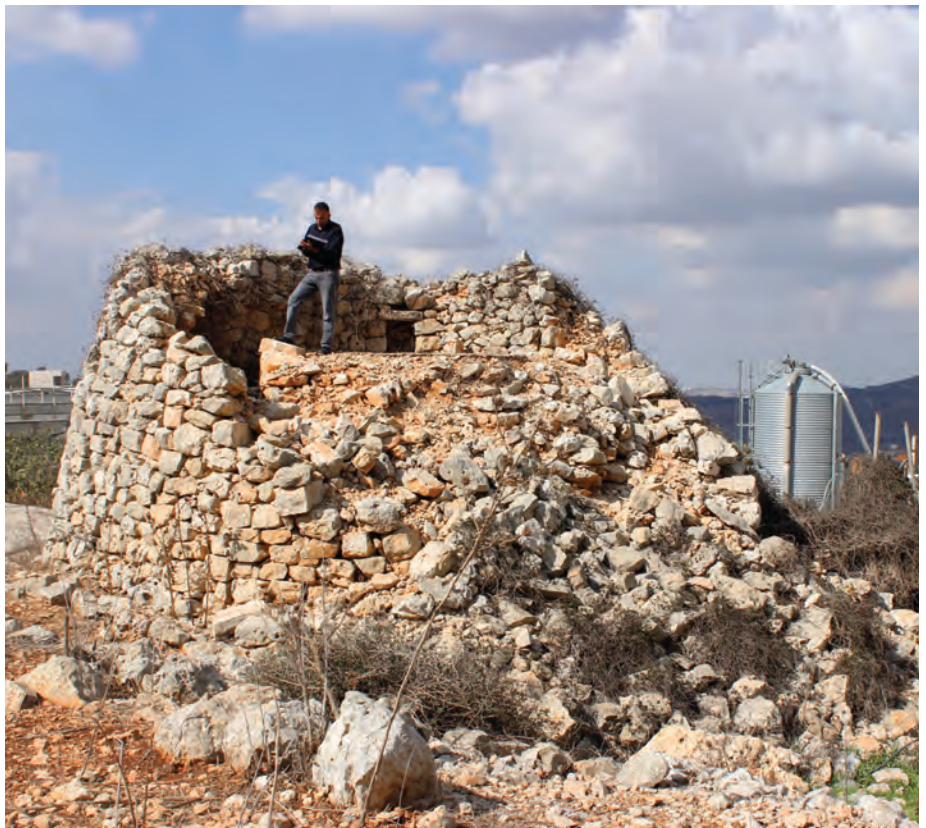
Figure 4. Corbelled, round stone watchtower, looking west, 2016. Photo by S. Al-Houdalieh.

The fieldwork at Khirbet Kafr Shiyān documented six of these stone watchtowers, which can be further classified into three types: round (3), quadrilateral (1), and irregular, solid stone mounds (2). The round (fig. 4) and quadrilateral watchtowers are all built with an internal domed space and two levels connected via an internal staircase. The ground floor was for livestock and storage and the upper level took the form of an open roof terrace used as living space and for daily tasks. By contrast, the watchtowers built as solid stone mounds look like an irregular heap of stones with an external staircase on one side.

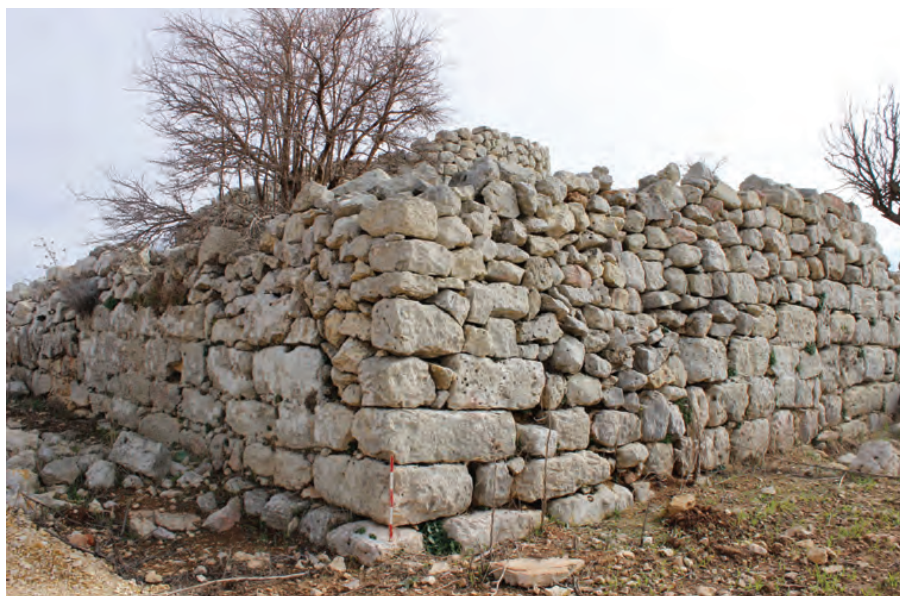
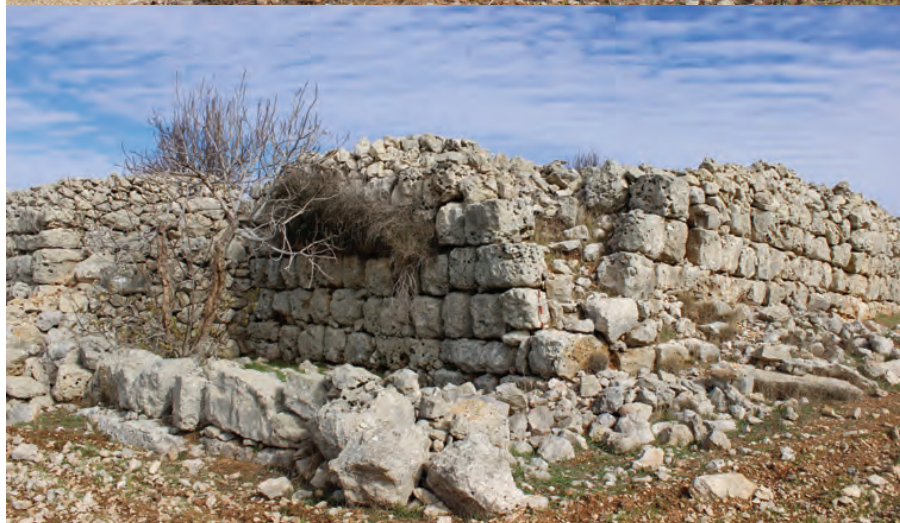
Figure 5. Remains of ancient walls, looking southeast (a) and northeast (b), 2016. Photos by S. Al-Houdalieh.

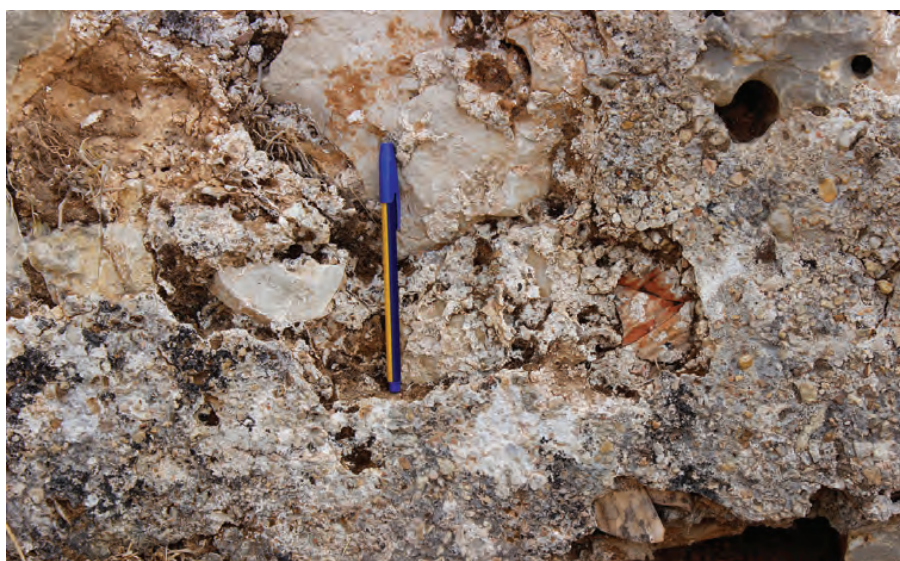
Figure 6. Traces of in situ plaster layers, looking east, 2016. Photo by S. Al-Houdalieh.

thick plaster layer consisting of lime mixed with soil, grog, gravel, and ash, traces of which can be seen in situ in several places, mainly on the external faces (fig. 6), as well as on several of the fallen stones. Most of the documented wall segments are joined to each other at right angles to form the corners of rooms or buildings of various sizes.

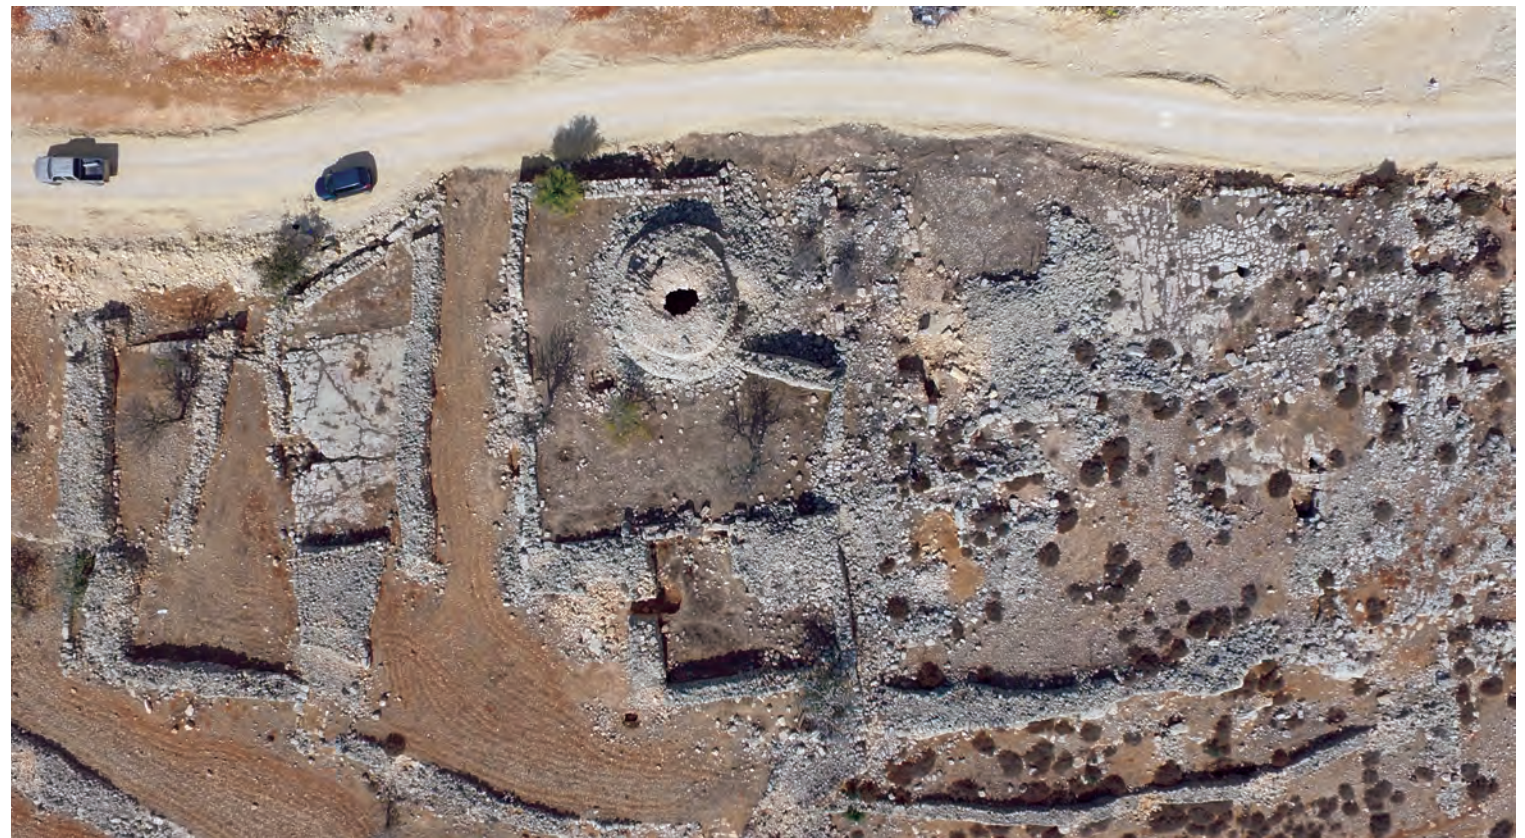
Figure 7. The large construction at the summit of the khirbet, 2016. Photo by Maher Barghouthi.

One remarkable building is located on the summit of the settlement, measuring 24 m × 20 m and flanked by several rooms to the south and east (fig. 7). Historically, this building was approached from the west through a door opening, the southern side of which is still in situ. Based on the building method of the documented walls, the size and cutting technique of the stones, and the numerous Byzantine pottery sherds embedded in the surface plaster layer, most of these walls can be dated to the Byzantine period.

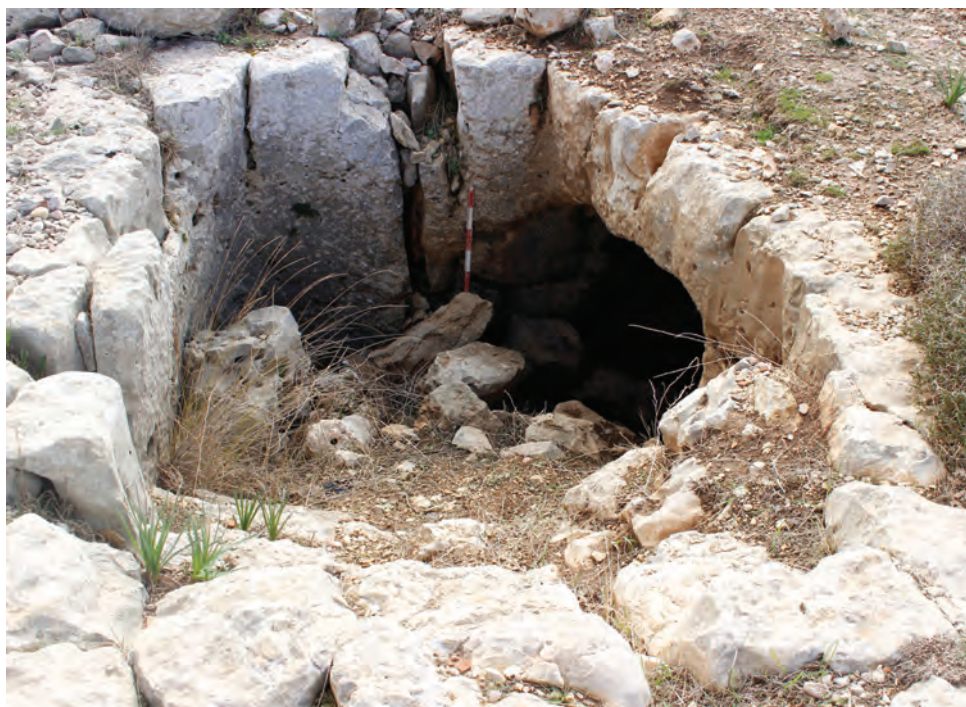
Figure 8. Vandalized Roman-era ritual bath, looking south, 2016. Photo by S. Al-Houdalieh.

Two cave-like installations were documented: one in the western section of the khirbet and the other in the eastern. Both are hewn into the bedrock, semi-circular in shape with similar internal dimensions, and their walls and ceilings are coated with hydraulic plaster layers. Their doorways are 1.5 m wide, on average, and at least 1.6 m in height. A large freshly opened hole was identified inside each of the two installations, which may indicate that both have been vandalized during the last few years. The eastern installation (fig. 8) is at least 2.5 m wide × 2.2 m deep × 1.6 m height (the floors were covered by an unknown thickness of erosion deposits). It is accessible via at least six hewn steps 1.7 m in width leading down from the surface. A large water cistern is located just to the north of the staircase, outside the hewn, plastered cave. Thus, it is believed that this installation, and perhaps the other as well, served as ritual baths during the Roman period.

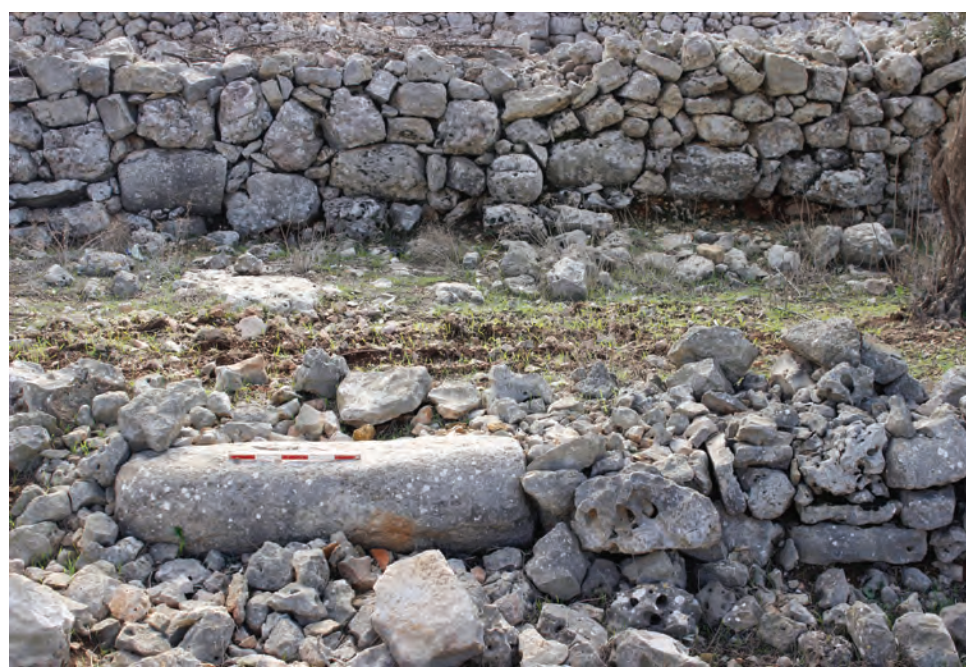
Figure 9. Column drum incorporated in a terrace wall, looking south, 2016. Photo by S. Al-Houdalieh.

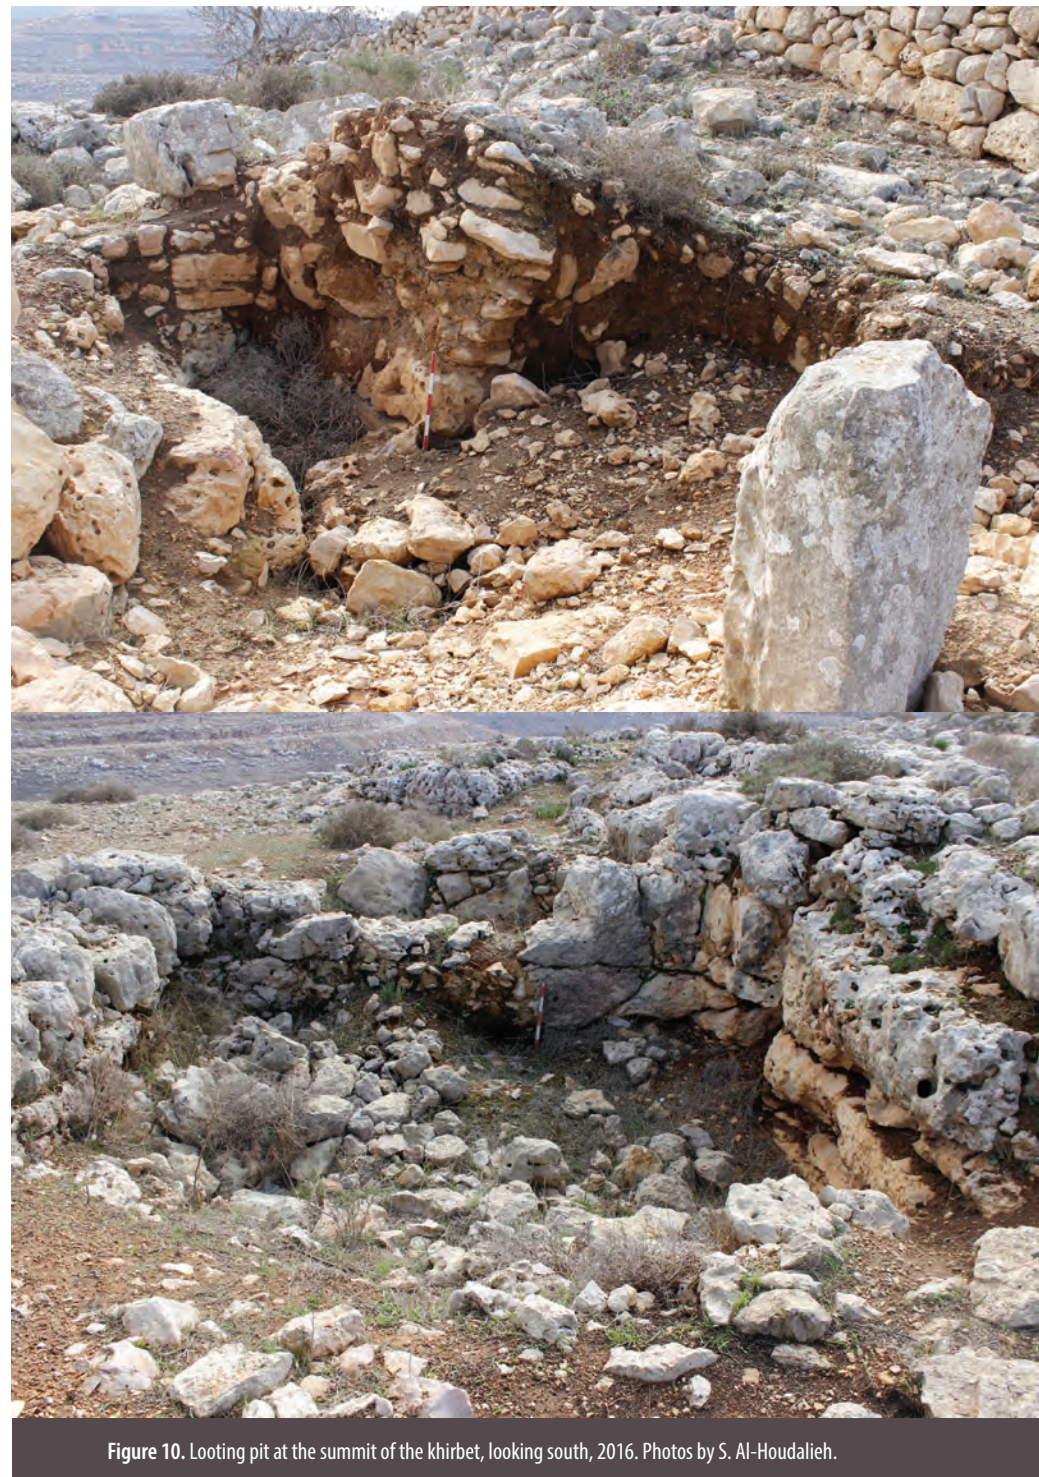
Figure 10. Looting pit at the summit of the khirbet, looking south, 2016. Photos by S. Al-Houdalieh.

As mentioned, Al-Houdalieh has documented in a previous research project, thirty-five looted Roman-era tombs at this site. Moreover, during this present research project we identified thirty-one new looting pits scattered all over the khirbet, the majority of which were documented on the summit of the settlement. These pits, some of which were freshly excavated, varied in size, shape, and depth: the largest pit measures 8 m \times 3 m \times 1.7 m deep, while the smallest one is 1.5 m \times 1.2 m \times 1 m deep (fig. 10). The antiquities looters have piled the excavated earthen deposits and rubble on one or more sides of their digging spots, and over time some of the removed material has eroded back into the pits. Such vandalism of the site has, without question, resulted in the destruction of well-stratified cultural layers and
